## Research Advances

## Study on the Fissure Rate in the Roof Strata of Excavated Coal Seams

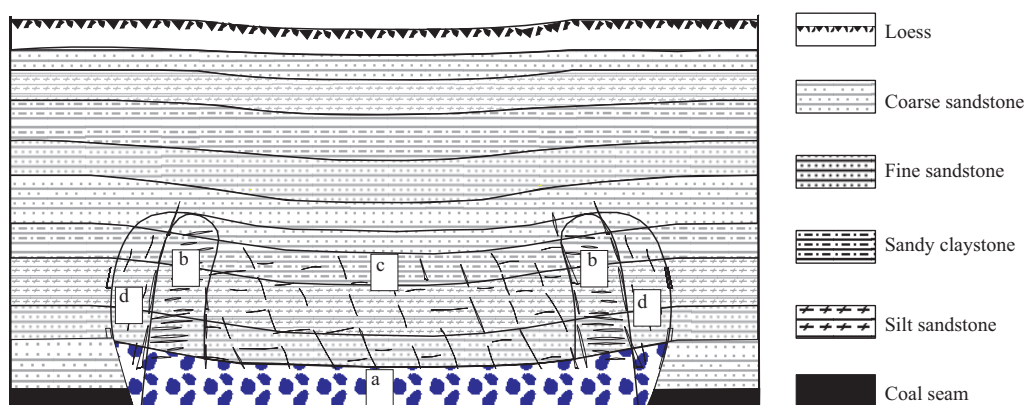
Fig. 1. Structural changes of roof aquifers caused by coal excavation in a type coalfield of North China.

The changing process of roof aquifers during coal excavation is as following: along with the initial cut of working face, fissures developed in the falling zone A and border cracking zone B as illustrated in Fig. 1. As working face pushed forward, the cracked zone B was compacted into zone C. The outside of the zones A, B, and C is zone D with a slight structural change. The outside face of the zone D has drastically changed permeability coefficients across this face; we defined this face as a curved face with permeability abrupt change (CFPAC). Our field observations suggest that the permeability coefficient  $k$  in zones A and B is larger than  $10^{-3}$  cm/s, while  $10^{-4}$  cm/s  $< k < 10^{-3}$  cm/s in zone C, and  $k < 10^{-4}$  cm/s in zone D.
